BULLRING ROOF STRUCTURE (PHASE 1)

BULLRING SHOPPING CENTRE BIRMINGHAM B5 4BU

SCOPE OF WORK

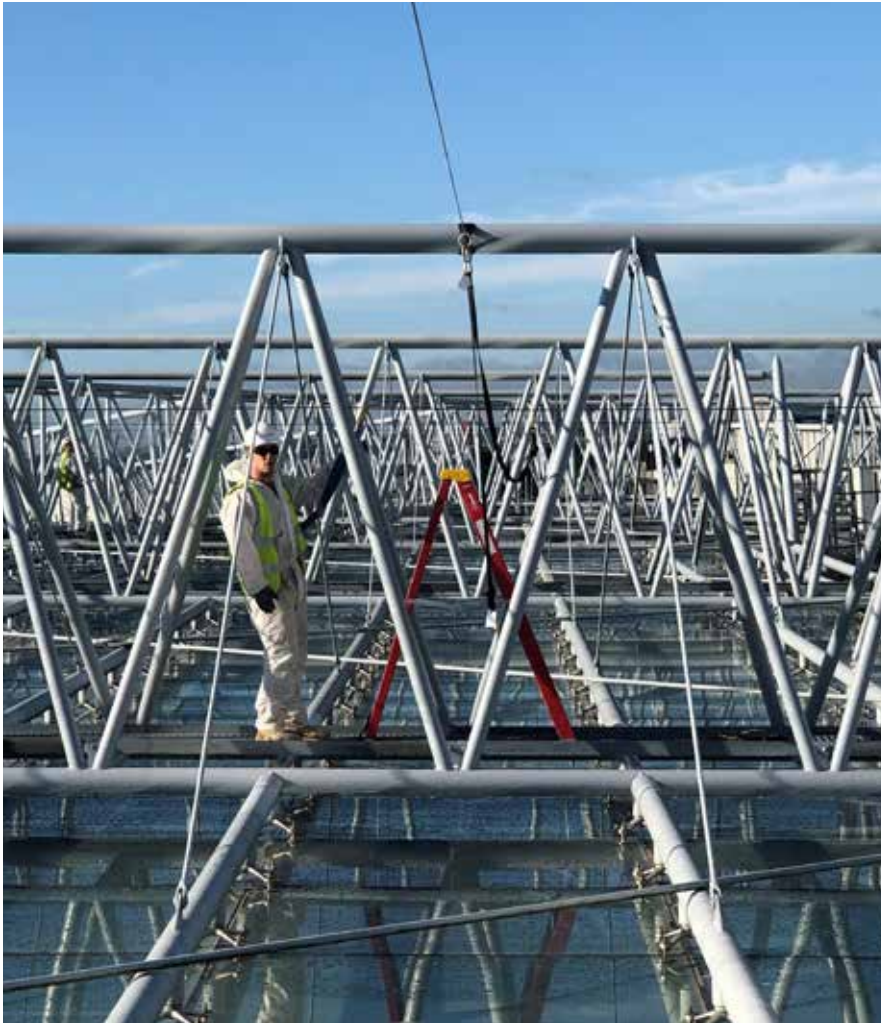
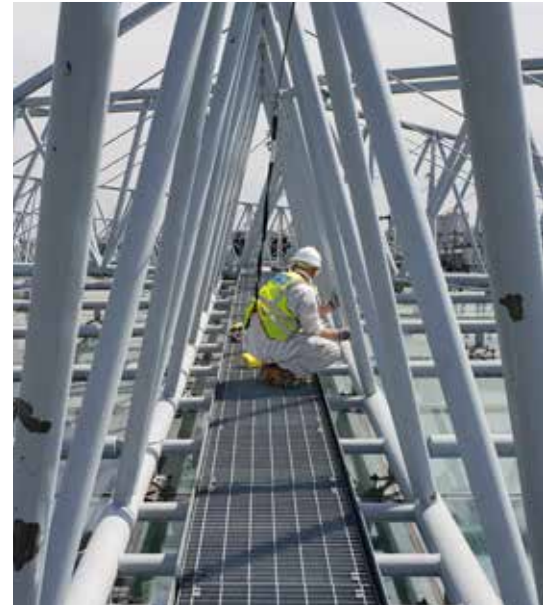
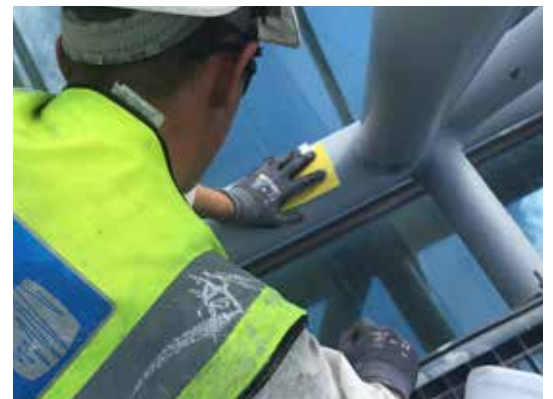
Phase 1 of the works involved cleaning and preparing the existing painted steel structure to the required St 2 and St 3 preparation standard, as specified by the specialist coatings supplier Sherwin Williams. Once preparation was completed to the specified standard Macropoxy C88 (an epoxy primer / build coating) was applied, followed by Acrolon C237 (an epoxy top-seal coating) to all cleaned and prepared areas.
